Manhole Inspection Summary

Manhole # S11Q__011MH

Insp Date: **4/18/08 10:33 AM**

Location Address: **549 S Caton Ave**

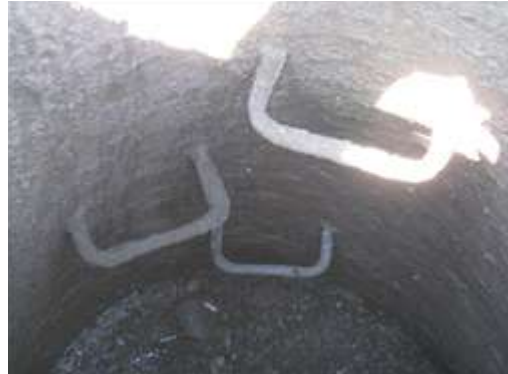
Defect 7

Count: **8** Missing: **0** ☒ **Corroded**

Corroded steps/Infiltration in Barrel

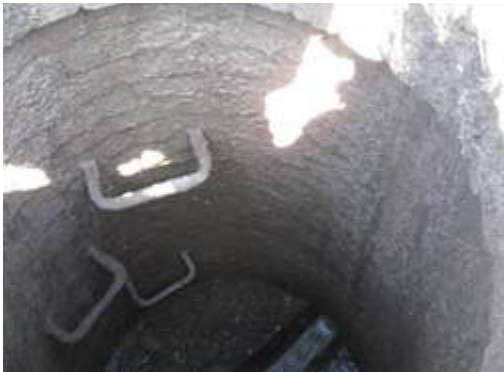
Defect 6

Condition: ☐ Sound ☐ Cracked ☐ Root Intrusion ☒ **Loose Brick** ☐ Deteriorated

chimney loose bricks, Active infiltration under chimney and corbel

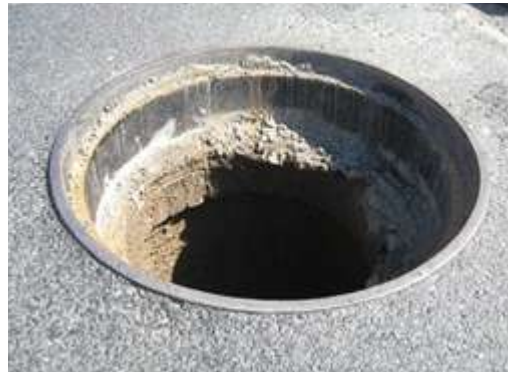
Defect 5

Infiltration from top

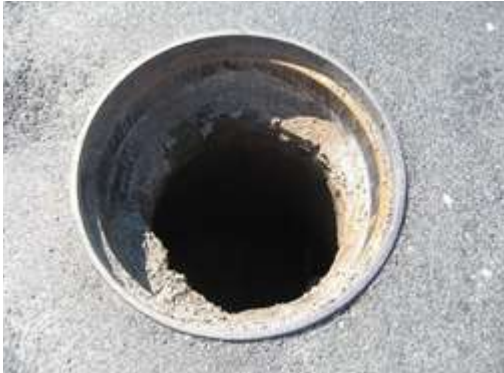
Defect 4

Offset: **4** (in.)

frame offset

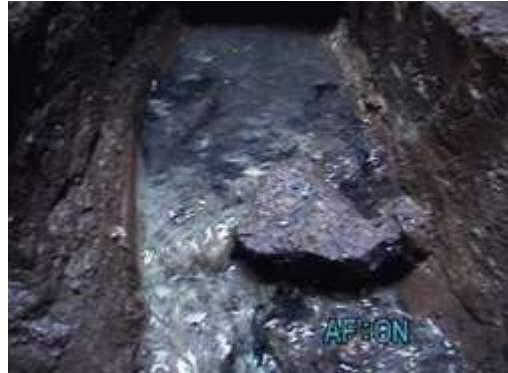
Defect 3

Condition: ☐ Sound ☐ Cracked ☐ Root Intrusion ☐ Deteriorated ☐ Leaks ☒ **Debris**

Heavy debris in channel

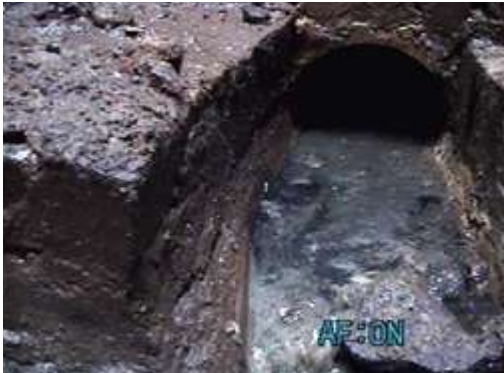
Defect 2

Heavy sediment on in channel

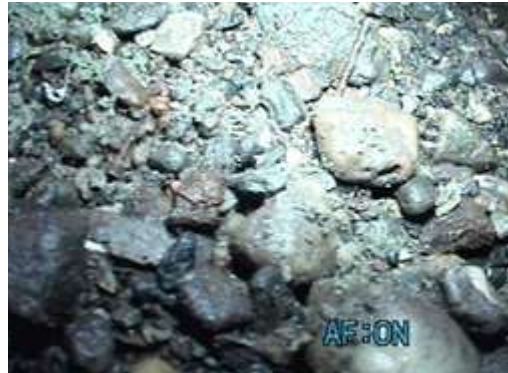
Defect 1

Condition: ☐ Sound ☐ Cracked ☐ Root Intrusion ☐ Deteriorated ☐ Leaks ☒ **Debris**

Heavy sediment on bench

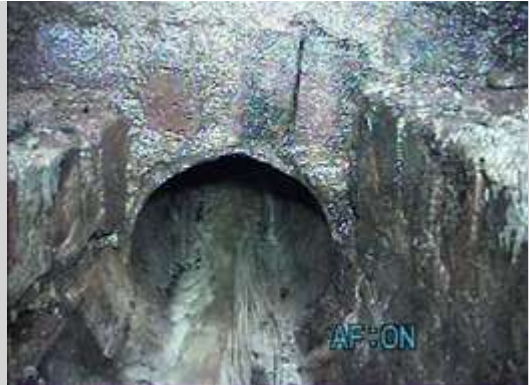
12 O'Clock Outflow

Barrel infiltration

Infiltration: **Evidence** Pipe Seal Cond: **Unknown**

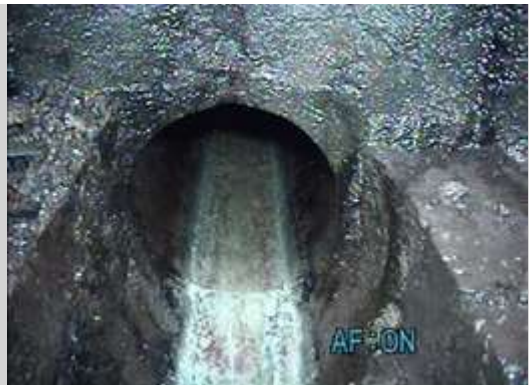
6 O'Clock Inflow

Infiltration: **Evidence** Pipe Seal Cond: **Unknown**

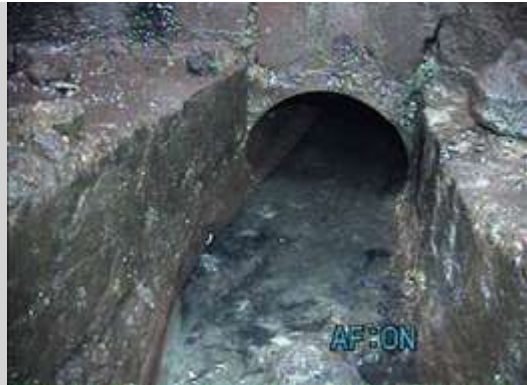
9 O'Clock Inflow

Infiltration: **Evidence** Pipe Seal Cond: **Unknown**
